Dangers of Under-Preparedness and Disregard Towards environment – A Study on Uttarakhand Flash Floods of Feb ‘21

Abstract

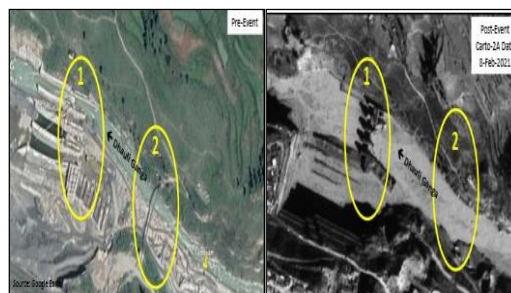
Figure 3: Satellite Images showing Damages to Power Project, (2) Bridge

Rapid damage assessment was carried out of the affected areas using high-resolution satellite images. Indian Cartosat-2S images show damages at NTPC Power Project at Tapovan (Figure 3& 4). Table 2 shows the details of lives lost and damage/loss to infrastructure.

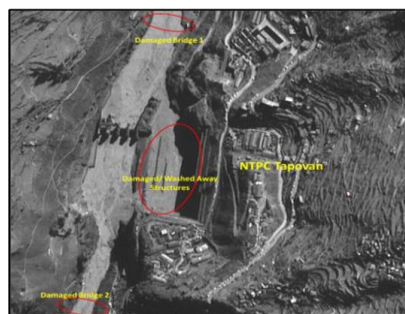
Figure 4: Satellite images showing Damages at NTPC, Tapovan
