## Seismic Vulnerability Assessment of Sid Maiza Mosque

### Abstract

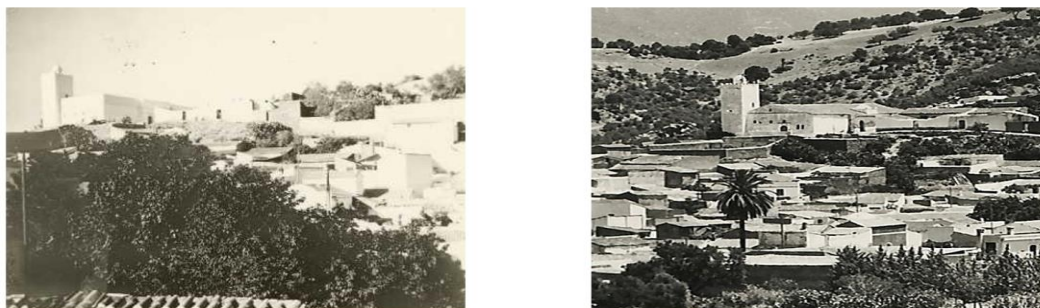
**Figure 3: The Sidi Maïza Mosque in Old Ténès dates from the 9th Century the National Agency for Antiquities and the Protection of Monuments and Historic Monuments - Agence Chlef.**

When one enters the interior of this secular building, one finds attached to the north facade of the mosque an ablutions room and a small courtyard in which is the tomb of Sheikh Sidi M'ammâr. Then, by taking a small, slightly diagonal entrance, you reach the prayer room. This resembles in style to that of the mosques of Damascus, Cordoba, Kairouan or the al-Hassan Mosque in Rabat.

In addition to its five naves parallel to the qibli wall, divided into eleven bays, four of which support arches perpendicular to the qibla wall, the mosque has a mihrab on a polygonal plan with an octagonal niche. A model that can be found in all the medieval mosques of western Algeria and which strongly resembles that of the great mosques of Kairouan and Cordoba. With the only difference that the mihrâb of Ténès is “shifted by one nave towards the east and is preceded by a dome which emerges from the roof with a crushed cap and four corner merlons”. According to R. Bourouiba, “this shift would have been intentional originally for the sake of respecting the Medinese type”.

Although it suffered significant damage during the great earthquake of 1954, which required rehabilitation works, which modified the original plan, the mosque was once again damaged following the earthquake of 1980. A study temporary protection was then carried out, but it was not until 1996 that the National Archaeological Agency carried out rehabilitation work.
