A Numerical Study of Landslide Treatment Techniques Applied in the Algerian Highway

So, the present study aims in first time to show the effect of the used geotextiles layers to reinforce the embankment through a practical pathological case of a landslide that occurred on the highway East-West of Algeria "A1", at the section of Tlemcen (North-West of Algeria) on July 14th, 2009. The numerical analysis are conducted both on geosynthetic-reinforced slopes and on the sloop with the presence of a retaining wall in two different configurations (wall only and wall rests on piles) as proposed solutions.

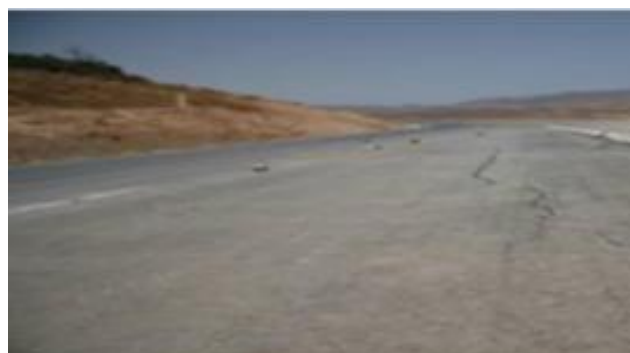
Fig 1: Cracks on the body of the roadway

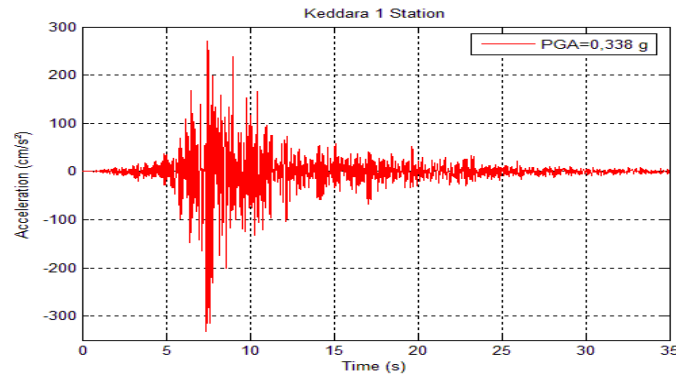
The seismic loading applied is that of the 2003 Boumerdes earthquake (May 21st), characterized by a magnitude of 6.8 and a PGA (Peak Ground Acceleration) of 0.34 g. The input signal was the E-W component recorded at Keddara Station (Figure 3).

Fig 3: The seismic loading applied

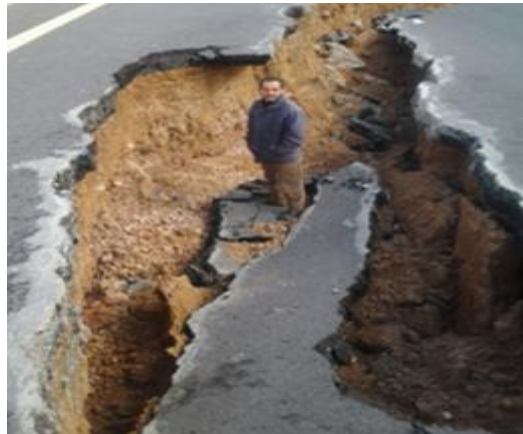
In this section we discuss the landslide which occurred on March 2nd, 2014 on the section of the East-West highway of Algeria located near the town of Tlemcen (West of Algeria). Indeed, the platform at Pk52+040~Pk52+093 suffered significant deformations, where the back wing moved vertically over 2m and 3 to 4m horizontally. Thus the left side of the road was completely stopped for traffic as it shows the photo in Figure 5.

Fig 5: Deformation of the pavement body, PK 52+040~093
