An Assessment of the Impact of Nigerian Erosion and Watershed Management Project (NEWMAP) on Gully Erosion Control in Enugu and Abia States

Emeh, Ikechukwu E¹, Ikeanyi, M.O², Atabo, Ichaba, S^{3*} & Didigwu, Nnamdi C⁴

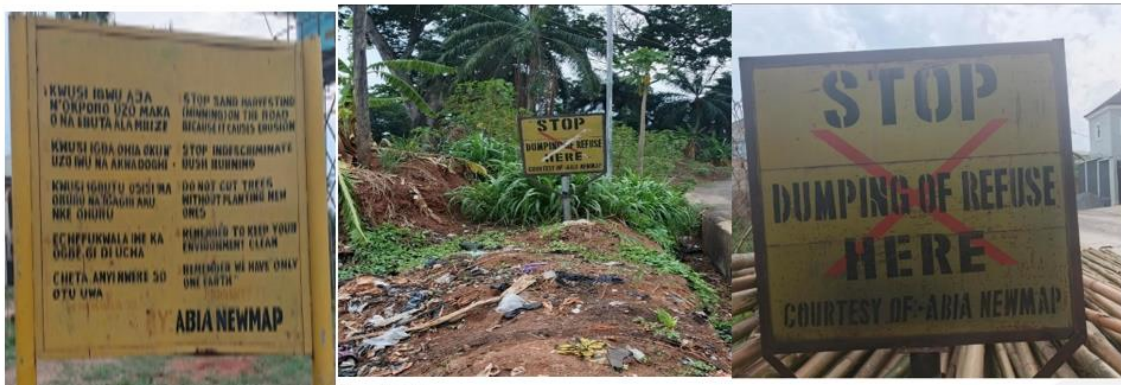
It is in recognizing that sustainable erosion control extends beyond engineering solutions, the project implemented extensive community engagement and sensitization programs aimed at education on erosion causes and prevention. This was pretty important given the fact that residents have turned the site into a massive refuse dump site. This trend continued after the intervention projects. And so part of the engagement was educating them about the underlying causes of gully erosion and the importance of adopting sustainable land-use practices to mitigate further degradation, under which sign posts against continuing dumping of refuges there were firmly established as shown below:

Fig ii: Awareness sign post for NEWMAP project sustainability in Amuzukwu-Umuagu-Ibeku

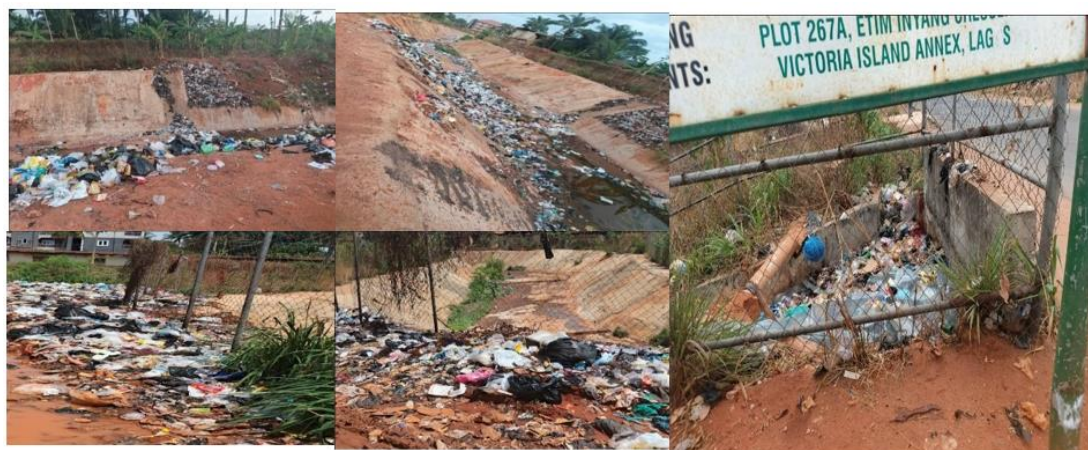
As a result of non-compliance to sensitization, the reclamation, channeling and remediation work Enugu state seems to be covered with refuges from the running drain.

Fig iii: Enugu Ngwo and Onuiyi gully site as an alternative refuse dumping site

By fostering awareness and understanding of erosion issues, residents are supposed to become active participants in maintaining the implemented structures and adopting practices that prevent further degradation. Sadly, there was not even a sign warning against this misuse.

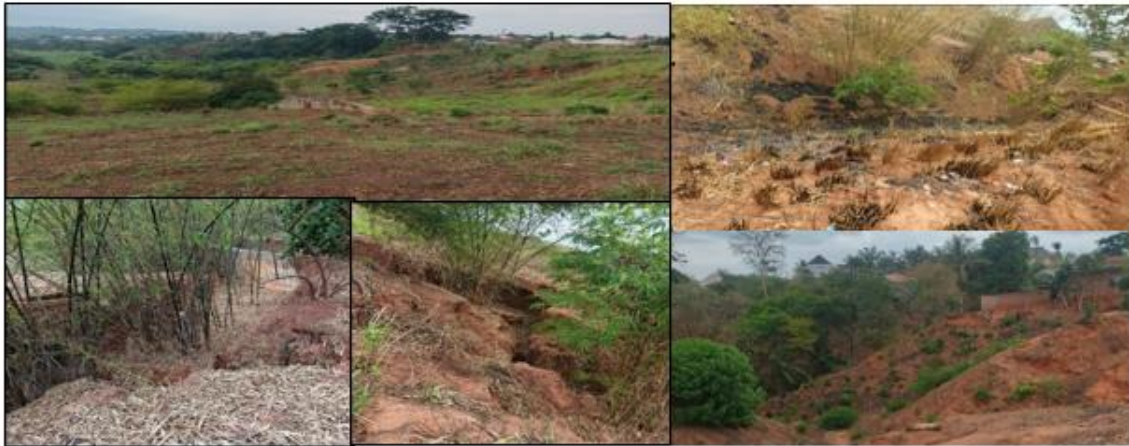
The intervention was supposed come with heavy afforestation because of its crucial role in restoring the degraded landscapes. Unfortunately, that was not the case. Where it featured at the Amuzukwu-Umuagu-Ibeku gully erosion site, afforestation was scantily done.

Fig iv: Scanty afforestation at Amuzukwu-Umuagu-Ibeku- Enugu-Ngwo gully erosion site

maintenance for post-project sustainability: Since it was observed that in almost all the projects, afforestation was not given its pride of place despite its relevance being opulently announced in extant literature, we strongly recommend immediate revisit of those sites with scanty afforestation yet in dire need of it. Also, emerging gully formations in the various communities where these various NEWMAP gully erosion intervention projects were carried out should be urgently worked on by the government of Enugu and Abia state. This recommendation is based on observed evidences of emerging gully erosions escalating into monumental threats. Further waste of time before attending to them will be costlier than these projects executed by NEWMAP under this stringent financial condition. Some of the fixed gully erosions have started showing sign of corrosion in their basements. This is very typical of the Amuzukwu-Umuagu-Ibeku gully erosion project.

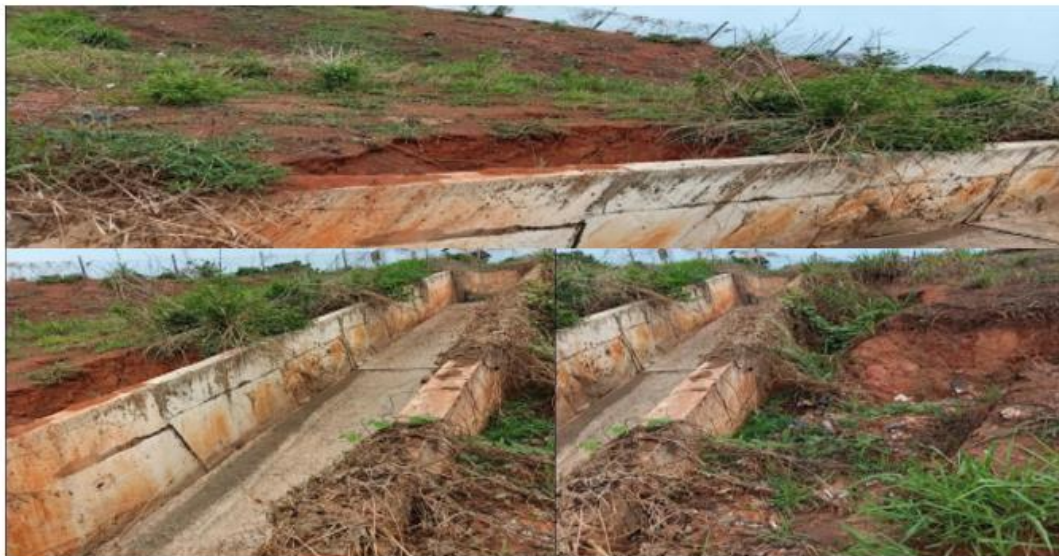
The scantiness of the afforestation implementation has had a huge toll on the sustainability of the executed project. For instance, instead of achieving soil stabilization that reduces soil erosion by anchoring soil particles and decreasing the velocity of surface runoff as well as achieving a significant return of various fauna that contributes to the restoration of the local ecosystem what we have is soil leaching that has negatively impacted the completed project. These soil leaching can have significant devastative impact on the sustainability of the project as it recreates emerging gullies within the immediate environment of the completed project. Apart from those effect already shown in the pictures above, such soil leaching has shown direct impact on the project as shown in the pictures below:

Fig v: Effects of scanty afforestation at Amuzukwu-Umuagu gully erosion control project

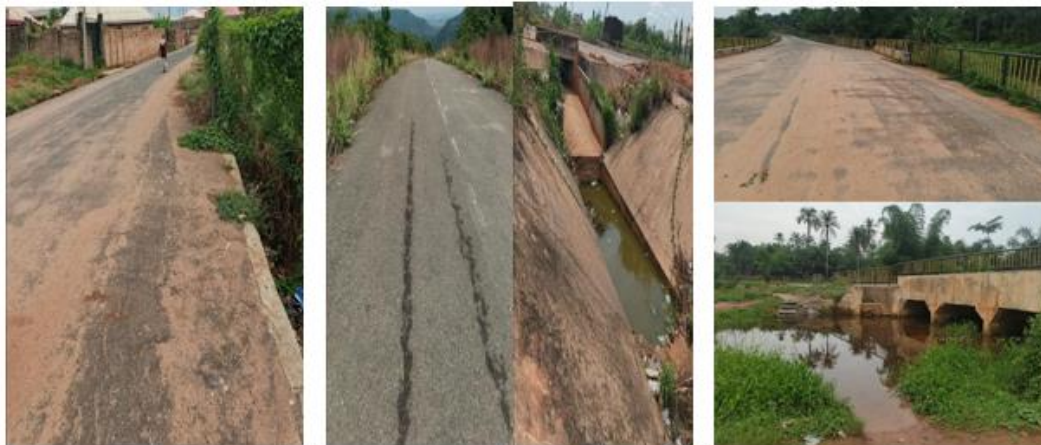
The remediation work carried out by NEWMAP in Enugu and Abia state featured a significant number of roads and bridges. While some bad roads and bridges were fixed, there are instances where new ones were created as a damage control measure to the completed gully erosion control projects. For instance, Amuzukwu-Umuagu, Umuogele and Amuda-Achara communities, gully erosions had torn the linking road into shreds thereby making it difficult for motorists and even pedestrian to connect between these communities. However, with the coming of the NEWMAP intervention, the road was repaired with solar-powered street light as shown in the picture below:

Fig vi: The repaired roads at Amuzukwu, Umuogele, Amuda gully erosion control project site

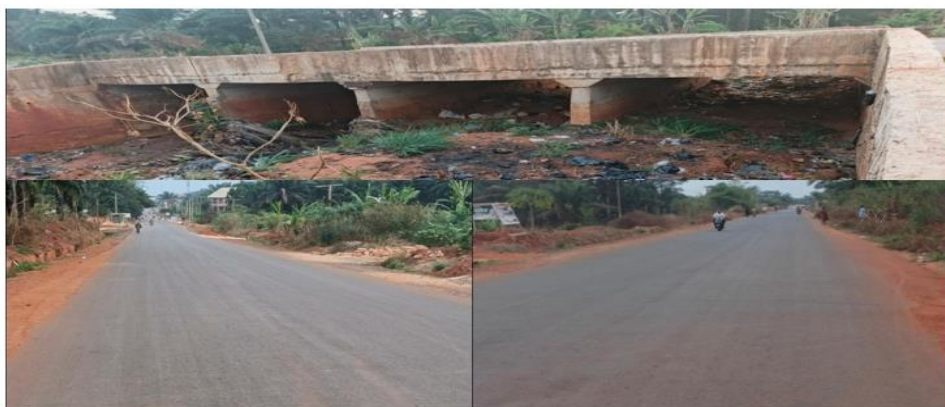
At the Onuiyi-Alor-Uno gully erosion site, two major bridges were built- one at the Zik's house axis of the erosion gully and the other at the MCC road that linked Onuiyi community to Alor-Uno community. The MCC road bridge came with a remedial work at the road itself that was until the NEWMAP intervention, a nightmare to motorists having been torn apart by galloping flood during rainfall. The pictures below show the bridge and the road recreated along the gully control projects.

Fig vii: A double view of a newly constructed road and bridge at MCC road Alor-uno gully site

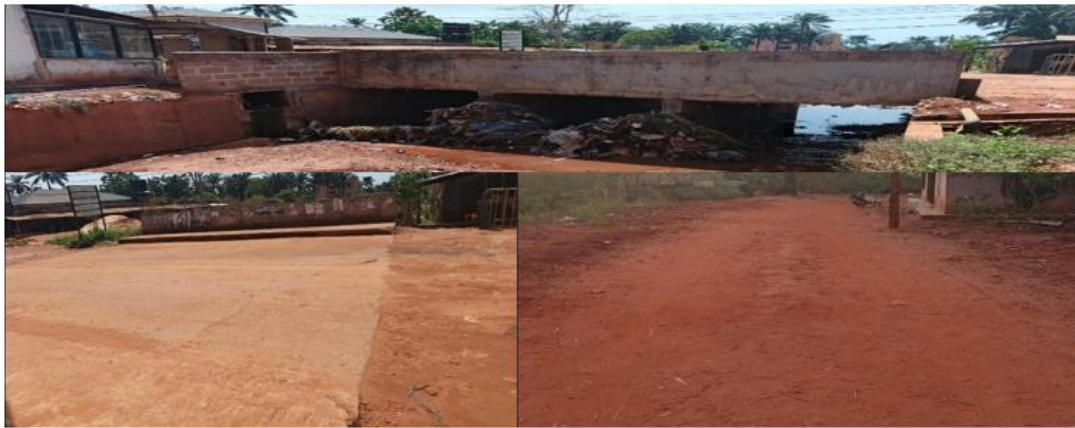
These bridge and road also have remedial culverts that connect Amaogbo to the MCC road. Amogbo community shares this gully erosion menace with Onuiyi and Alor-uno hence any remedial action or intervention is expected to include it. Below are Onuiyi Bridge and roads

Fig viii: The Onuiyi erosion re-constructed bridge and recued roads at Ibeziako Street Onuiyi

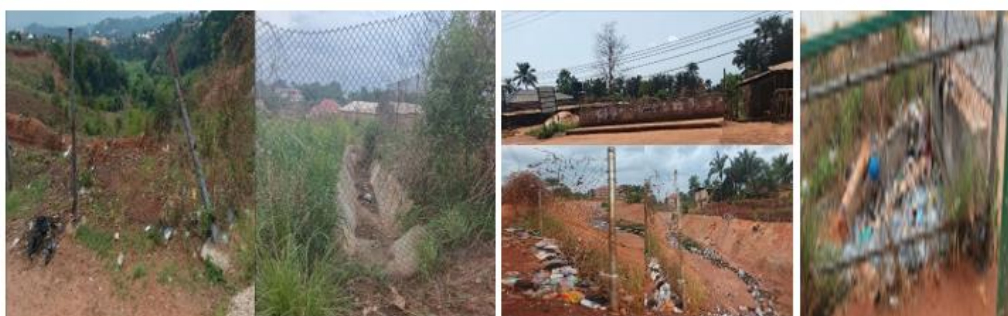
The remediation works carried out by NEWMAP in Enugu and Abia states were significantly provided for protective measures. The roads were provided with solar powered street light while the bridges and culverts were provided with protective rings and steel fence with wire gauze. These safety measures were created as damage control measure to the completed gully erosion control projects in both states. For instance, at Amuzukwu-Umuagu, Enugu-Ngwo and Onuiyi-Alor-uno gully erosion site, there were visible protective ramps at both edges of the repaired road and steel fence with wire gauze was fixed as part of the damage control as shown below:

Fig ix: A view of the installed steel fence at Amuzukwu-Umuagu gully erosion sites

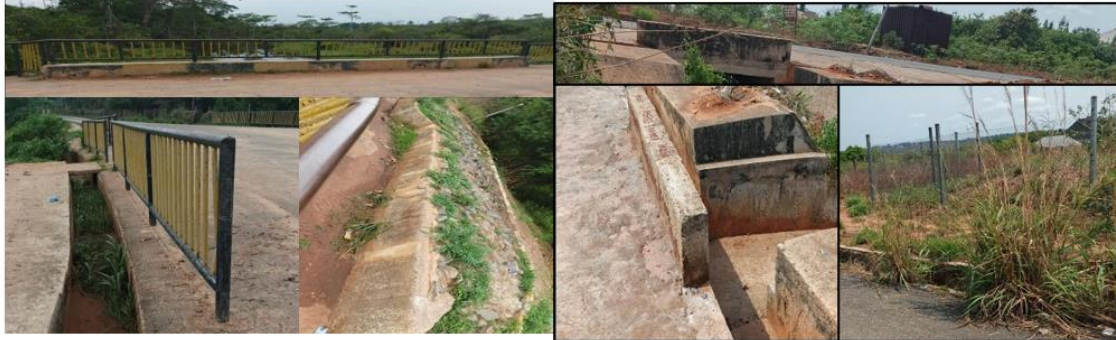
At Umuogele-Umuakwu and Amuda-Achara gully erosion site, there were visible protective ramps at both edges of the newly constructed bridge as well as the road and steel fence with wire gauze was fixed as part of the damage control as shown below:

Fig x: A protective measures at Umuogele-Umuakwu and Amuda-Achara-Isuochi gully site

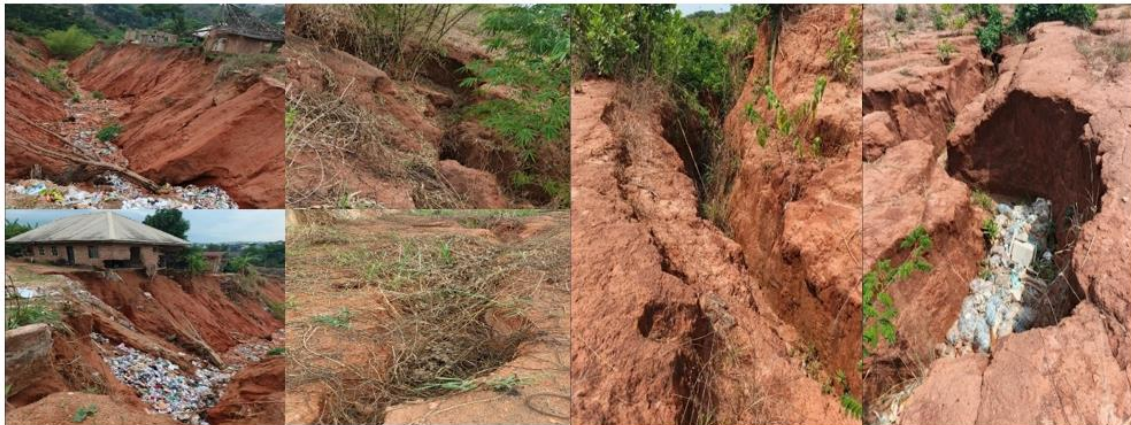
The NEWMAP intervention in Enugu and Abia states needed the fixing of emerging gully erosion as one of the Damage Control measures but unfortunately, both the key informant interview and on the spot assessment (observation) revealed zero attendance to this all-important component. For instance, at Amuzukwu-Umuagu gully erosion site, there are many emerging gully erosions and a very threatening one that the completed NEWMAP intervention did not capture but it has viciously ravaged the area to the point of forced displacement of residents.

Fig xi: A side view of full-blown erosion gully & emerging ones at Amuzukwu & Amuda

These pictures are testaments to and an example of agonizing experience that could have been avoided if this arm of Damage Control component was provided for. Residents and occupant have been forcefully evicted from their own homes by erosion gully and as it stands, more houses are going down into the gully as the raining reason gathers momentum and the soil has been deeply compromised. Unfortunately, hope is nowhere in sight for them as the project coordinator of Abia NEWMAP said that work will only commence there anytime

While these emerging gullies are not forming exactly at the place of NEWMAP intervention, concern is that if these emerging gullies are not fixed today, they will certainly become a threat too big to handle within few years to come. This fully formation within few years after the NEWMAP intervention was foreseen by the program think tanks who thought it wise to assert that damage control that comprises fixing emerging gullies should be part of the NEWMAP intervention package. These spots are just but a tip of an iceberg because there are many other emerging gully formations within these communities that could have been fixed in the course of delivering the Amuda-Achara Isuochi gully erosion intervention project.

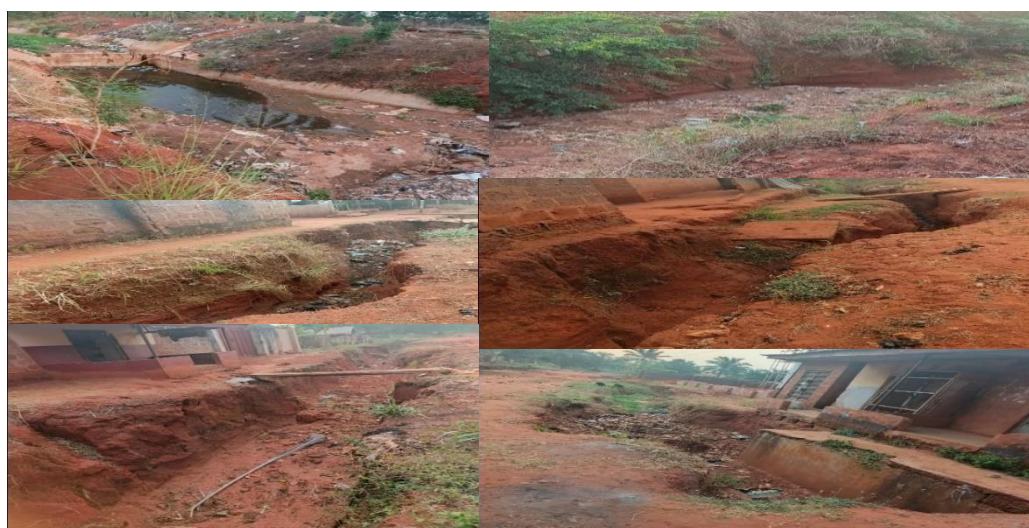
Unfortunately, the above listed and discussed are not all there are as the Onuiyi-Alor-Uno Nsukka gully erosion also has many emerging gullies that could have been fixed as a part of the damage control proviso to ensure the sustainability of this project. In fact, the case of OnuiyiAlor-Uno Nsukka gully erosion is more than it seems. For instance, firstly, the project was not completed hence the in-between where the engineering work has not been completed has continued to escalate in terms of depth and wideness. While the fear of the escalation due to seeming abandonment is still on the horizon, the speed with which the Amaogbo road that is connected to the Ibeziako street where the Onuiyi-Alor-Uno Nsukka gully erosion site is situated, is unimaginable worrisome. Even when the last NEWMAP intervention extended a culvert at the end of the street connecting it to the Alor-Uno end of the gully erosion, the area has been mopped up by emerging gully formations to the extent that about 25 building and 15 shops have been disconnected from the main road as residents and occupants improvise to have access to their homes. Some of these houses have actually lost their fence to these emerging erosion gullies. The pictures below show some of the emerging gully formations.

Fig xii: A view of emerging erosion gully at Onuiyi-Alor-Uno Nsukka gully erosion site
Source: Field study (2025)
